# Analysis of Quality Defects

Based on HQTS Inspection Reports for Home Appliances

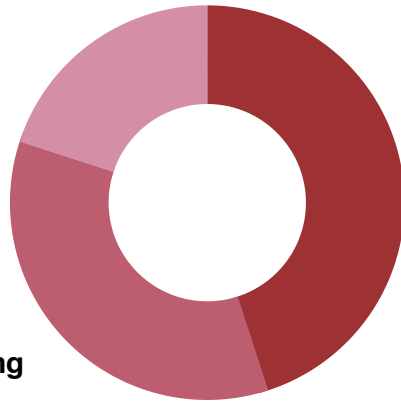
**Not Conform**  
20%

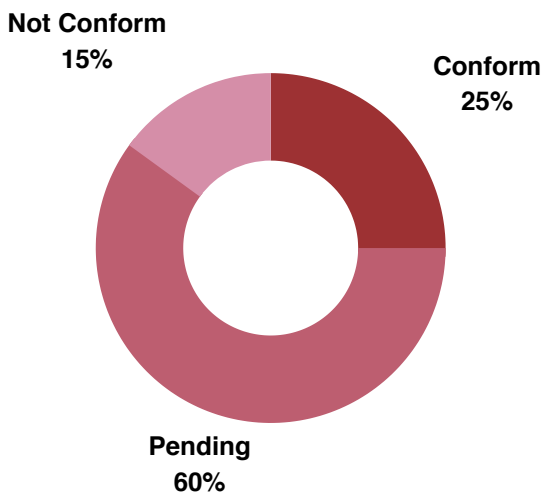
HQTS Inspectors will verify that the product specifications, construction data form (CDF) and instruction manuals are consistent with the samples.

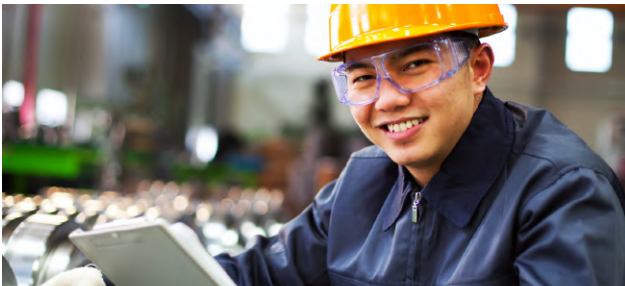
**Total Quality  
Every Step of the Way**

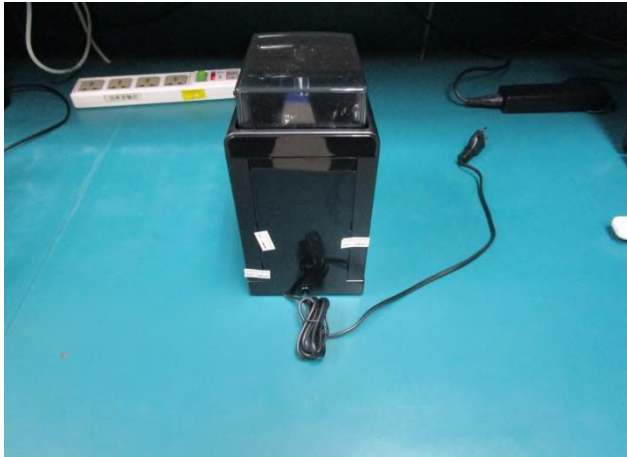
SAP 2.1 Flow mark and the gap (2mm) on the back

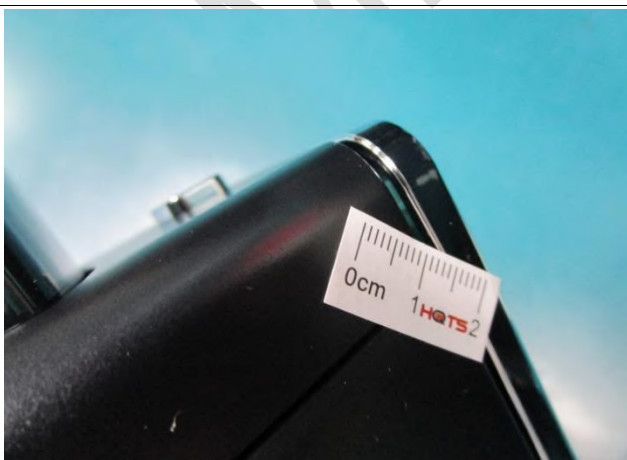
Defect-Poor assembly on the unit-major

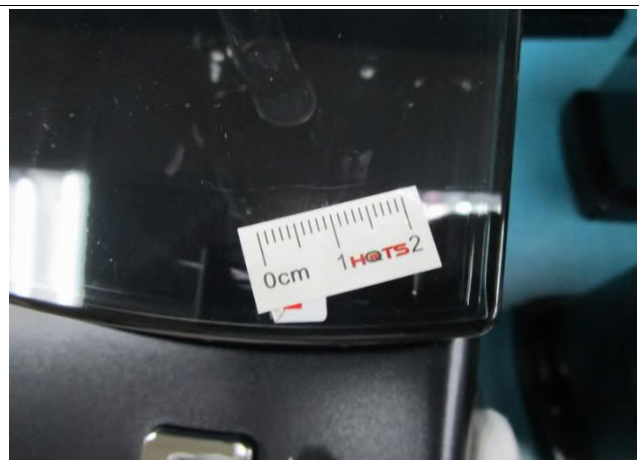
Defect-Scratch mark(2.2cm) on the top cover-minor

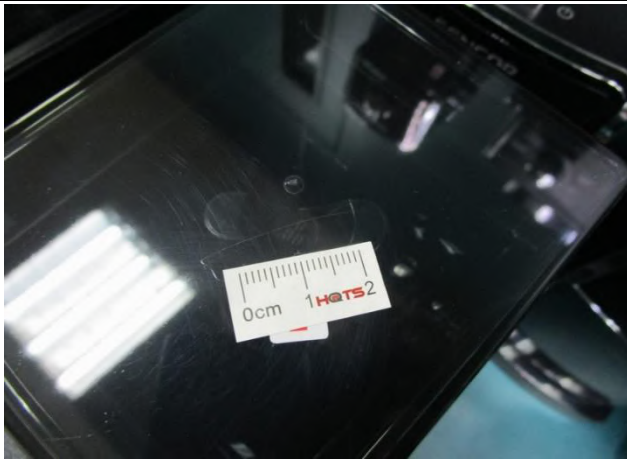
Defect-Scratch mark(2.3cm) on the top cover-minor

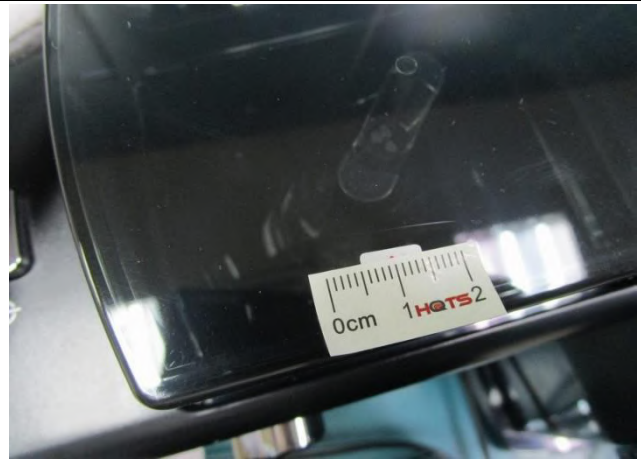
Defect-Scratch mark(1.2cm) on the top cover-minor

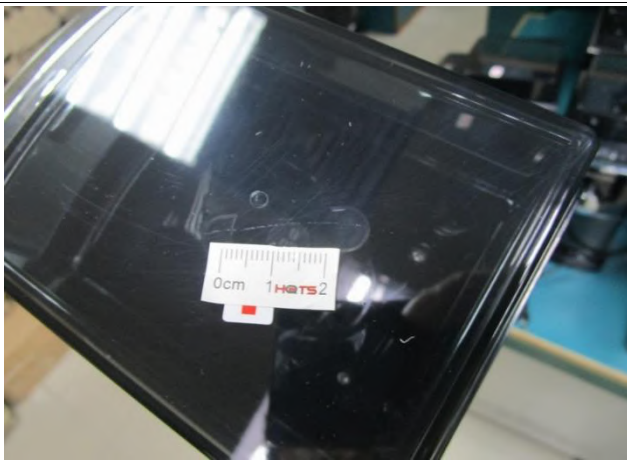
Defect-Scratch mark (2.2cm)on the top cover-minor

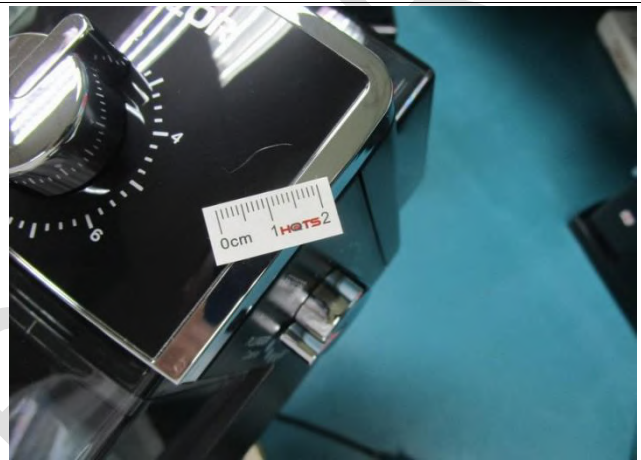
Defect-Scratch mark(1cm) on the body surface-minor

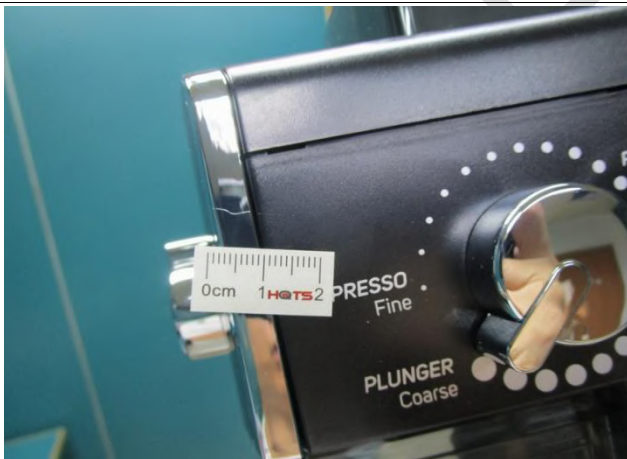
Defect-Scratch mark (1.5cm)on the body surface-minor

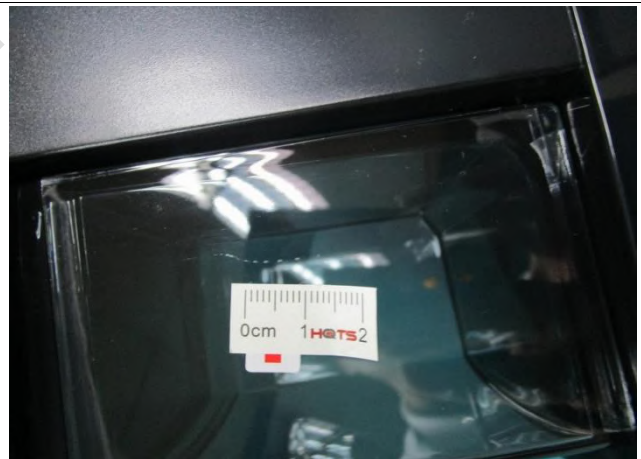
Defect-Scratch mark(1.5cm) on the container surface-minor
